REPORT DOCUMENTATION PAGE		READ INSTRUCTIONS BEFORE COMPLETING FORM
1. REPORT NUMBER	2. GOVT ACCESSION NO.	3. RECIPIENT'S CATALOG NUMBER
4. TITLE (and future)		5. TYPE OF REPORT & PERIOD COVERED
Fresh Air Fund Dam Site I Lower Hudson River Basin, Dutchess County, NY Inventory No. 288		Phase I Inspection Report National Dam Safety Program

PHASE I INSPECTION REPORT
NATIONAL DAM SAFETY PROGRAM
FRESH AIR FUND DAM I.D. No. NY 288
DEC #212D-1526 LOWER HUDSON RIVER BASIN
DUTCHESS COUNTY

PHASE I INSPECTION REPORT
NATIONAL DAM SAFETY PROGRAM
FRESH AIR FUND DAM I.D. No. NY 288
SITE 1
DEC #212D-1528 LOWER HUDSON RIVER BASIN
DUTCHESS COUNTY, NEW YORK

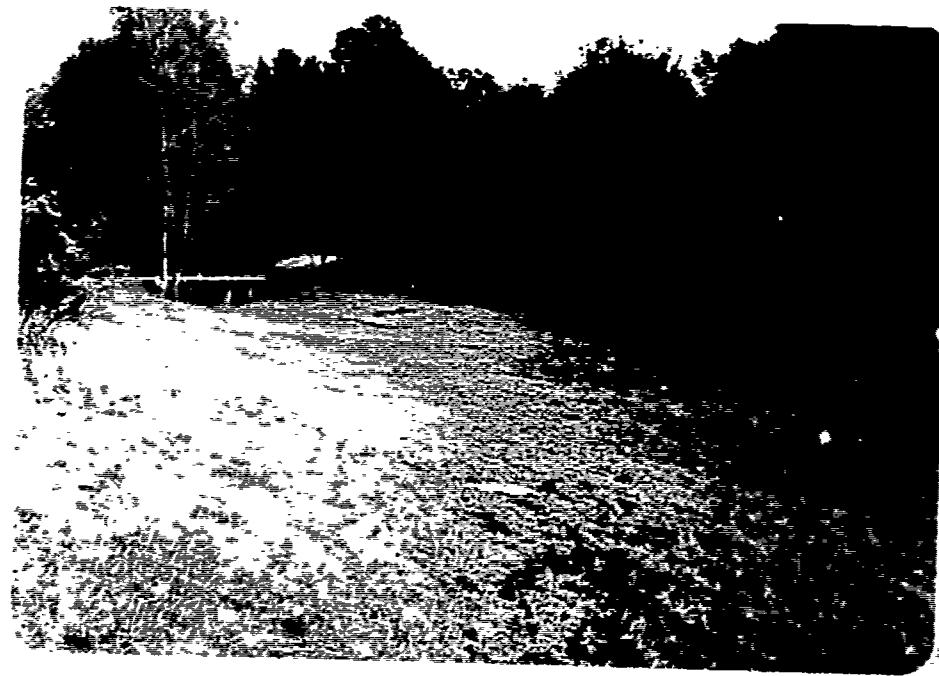
Photo #3
Auxiliary Spillway

No signs of major distress were observed in connection with the earth embankment. No evidence of misalignment, sloughing, subsidence, depressions, or surface cracking were observed on the embankment slopes or crest. (See Photos #1 & 4) The upstream slope at normal pool level was riprapped. (See Photo #4) Extensive vegetation was observed along the upstream slope, extending to the crest, at the left abutment contact, and at the downstream toe of the embankment. (See Photos #1, 4 & 5) Vegetation was also noted in the vicinity of Service Spillway intake (Photo #2) and on the banks of the auxiliary spillway adjacent to the access bridge. (See Photo #3)

The auxiliary spillway appears to be in good condition, with the exception of the trees adjacent to the access bridge.

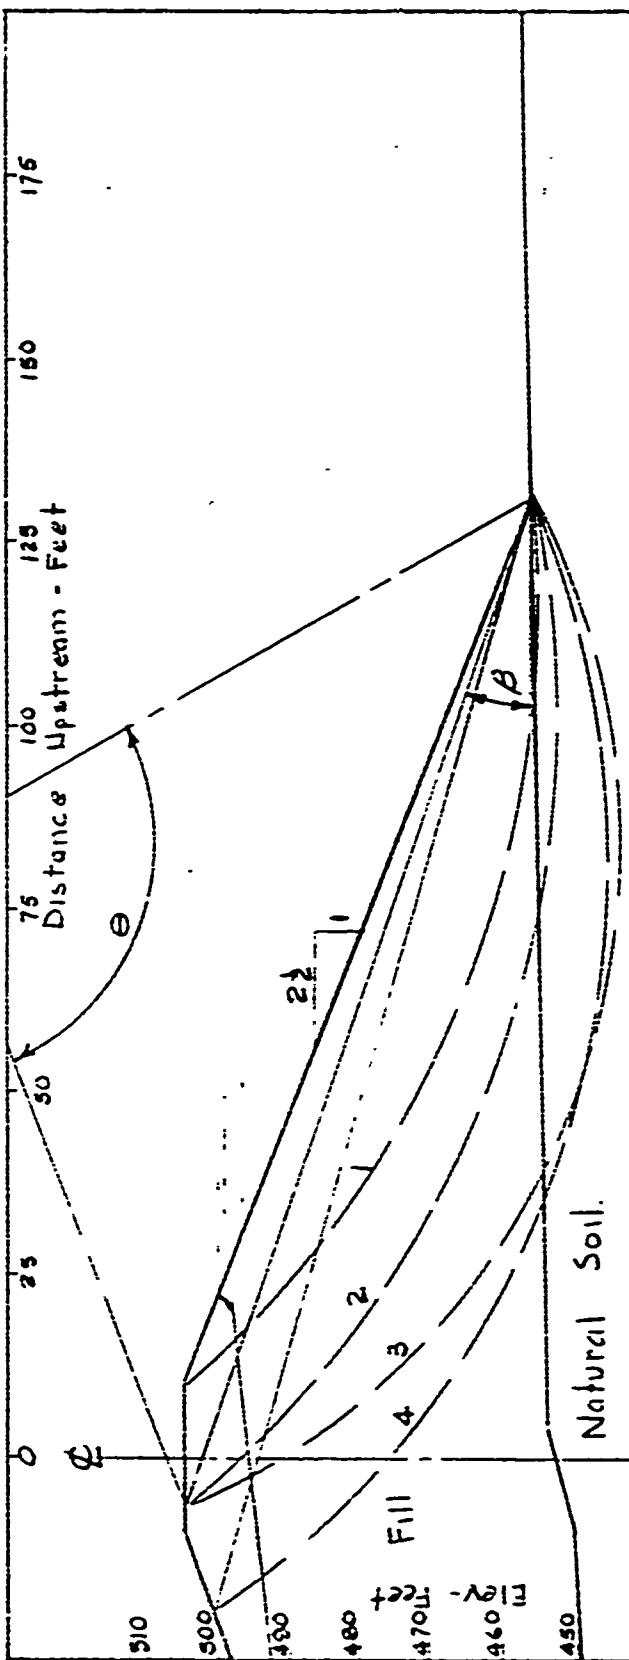
FIG. 10

Arc	θ	β	Factor of Safety		
			During Construction	Reservoir Full	Sudden Drawdown
1	56.4°	21.8°	1.42	1.96	1.028
2	64.1°	19.0°	1.29	1.65	0.86
3	97.0°	19.0°	1.33	1.63	0.853
4	81.5°	16.0°	1.46	1.75	0.925

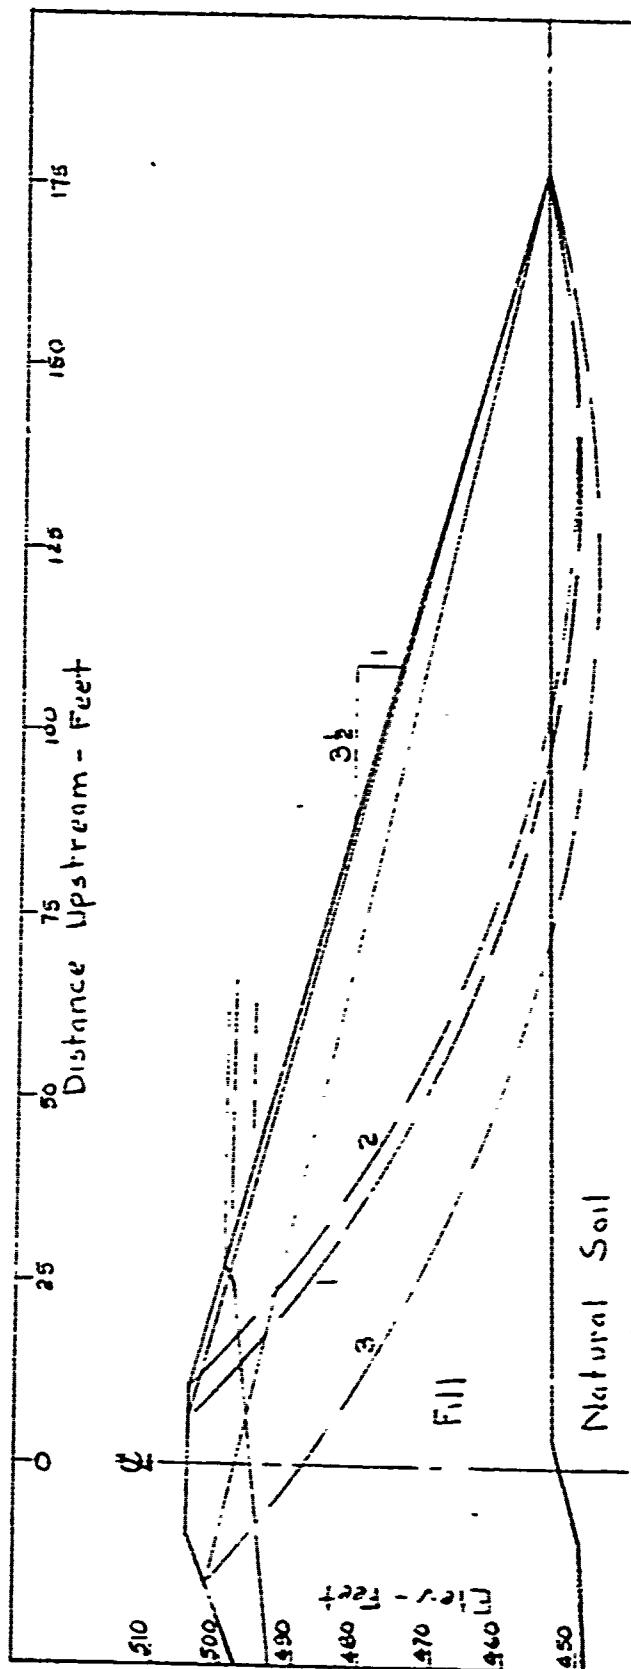
FIG. 25

Arc	Θ	β	Factor of Safety		
			D.uring construction	Reservoir Full	Sudden Drawdown
1	59.0°	15.5°	1.665	2.14	1.143
2	58.5°	15.9°	1.77	2.33	1.241
3	58.5°	13.0°	1.77	2.22	1.186

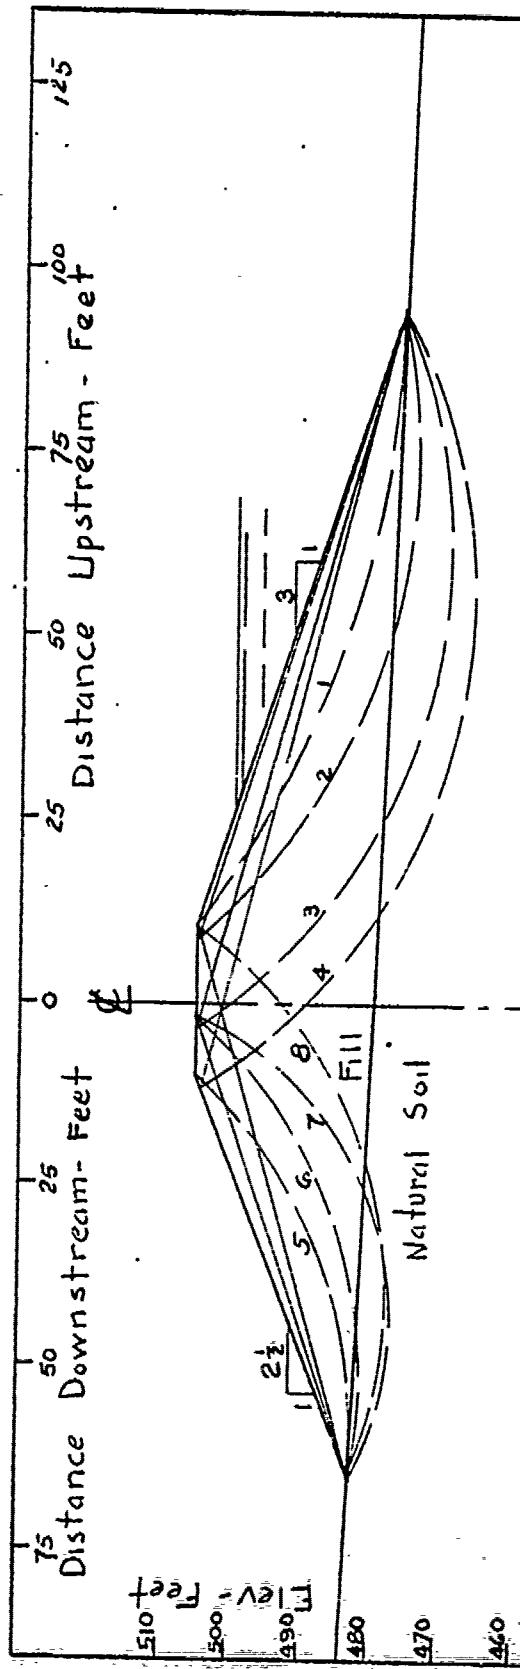
FIG. 27.

Arc	θ	β	Factor of Safety	
			During Construction	Reservoir Full
1	36.5°	18.28°	3.28	5.32
2	64.0°	18.0°	2.08	3.01
3	82.5°	15.8°	1.97	2.68
4	90.0°	14.5°	2.02	2.65
